MARYLAND HISTORICAL TRUST

INVENTORY FORM FOR STATE HISTORIC SITES SURVEY

Sant's Market

113 Montgomery Street (with 803 Leadenhall Street described)

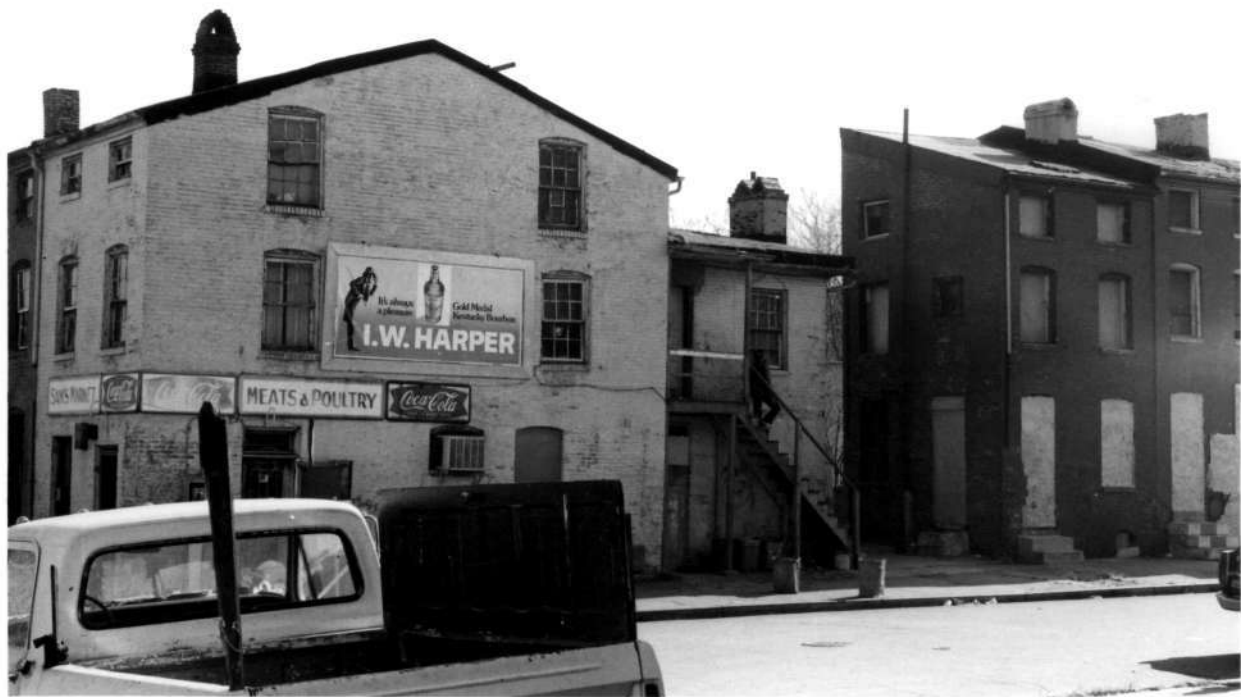
113 MONTGOMERY STREET B-2937

113 Montgomery is a 2½ story high, two bay wide gabled row house with a one bay wide, two bay deep, two story high back building. It is built of brick laid in running bond. The first floor of the main building houses a small grocery market.

An entrance on the right of the front facade is at ground level. It has a flat, running brick lintel. A window opening to the left has a flat splayed brick lintel and brick sill. A flat, painted metal sign runs across the facade at the second floor level.

Second floor window openings are segmental arched with brick sills, and are filled with double hung windows with 6/6 lights. The wooden frame between the top of the sash and the brick lintel is cut with jigsaw scrolls. A pair of small rectangular attic windows has running brick lintels and brick sills and are filled by double hung windows with 3/3 lights. A flat brick cornice runs at the roofline. A slim brick chimney covered with a brick arch rises from the left side of the front of the gable.
